REVIEW OF REMEDIAL ACTIONS

**McKay Elementary School
McKay Street
Beverly, Massachusetts**

Prepared by:
Massachusetts Department of Public Health
Bureau of Environmental Health Assessment
Emergency Response/Indoor Air Quality Program
March 2003

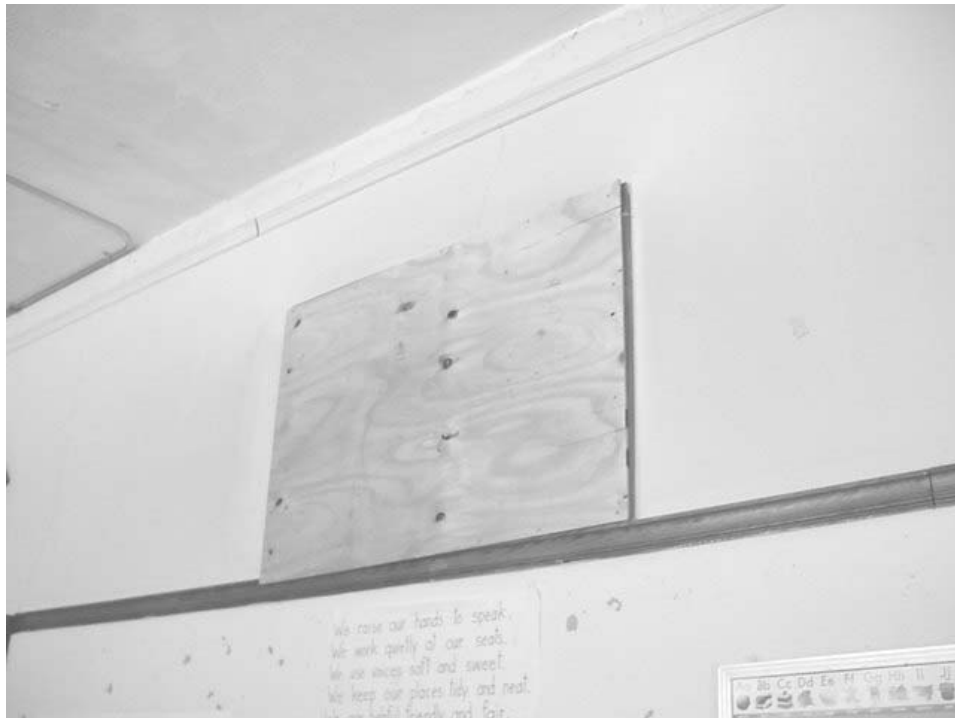
Picture 1

In an effort to decrease the migration of odors and particulates through the building, the fresh air supply and exhaust vents of the abandoned gravity ventilation system were sealed (see Recommendation 7 of MDPH January 2003 report). It can be seen from the tables that carbon dioxide levels were elevated above 800 parts per million of air (ppm) in thirteen of twenty areas surveyed. It is important to note that while several areas still exceeded BEHA's comfort guideline of 800 ppm, the majority of these carbon dioxide levels (9 out of 13) measured post remediation, are lower in comparison to those taken in the previous BEHA assessment (MDPH, 2003). These carbon dioxide measurements indicate that the sealing of the gravity system did not negatively influence natural ventilation in the classrooms compared to previous air sampling. Carbon dioxide levels would be expected to decrease as windows are opened when weather warms.

Example of Natural Gravity Vent in Classroom Sealed With Plywood and Caulking

Action Taken: All classroom supply and exhaust vents were sealed with plywood and caulking to create an airtight seal. Ventilation shafts were also sealed in the basement and on the roof as per BEHA recommendations. No decision has been made at this time concerning the full or partial restoration of the original ventilation system and its components.

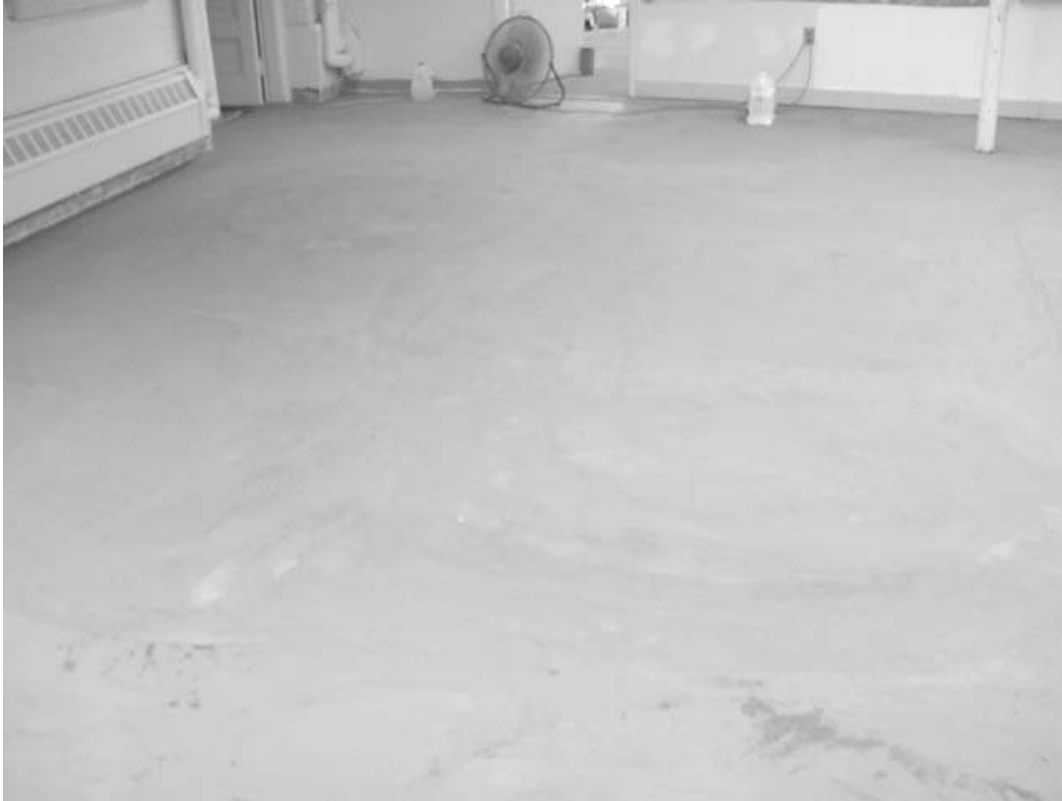
Picture 2

Basement Classroom Floor with Carpet Removed Prior to Tile Installation

Action Taken: All carpeting with the exception of the band room was removed and replaced with vinyl floor tile. Carpets and baseboard coving were removed and all areas were cleaned and disinfected with an antimicrobial agent by Abatement Control Services, Inc., a professional remediation company. No mold or moisture conditions were reported or observed by BEHA staff during the February 21, 2003 visit prior to installation of floor tile. Vinyl floor tiles were installed over the weekend of February 22-23, 2003 by a private contractor, Bass River Flooring. Mastic used to install floor tiles was a water-based/rubber resin material containing no organic solvents or reportable hazardous substances, with a 30 minute to a 6-hour curing time.

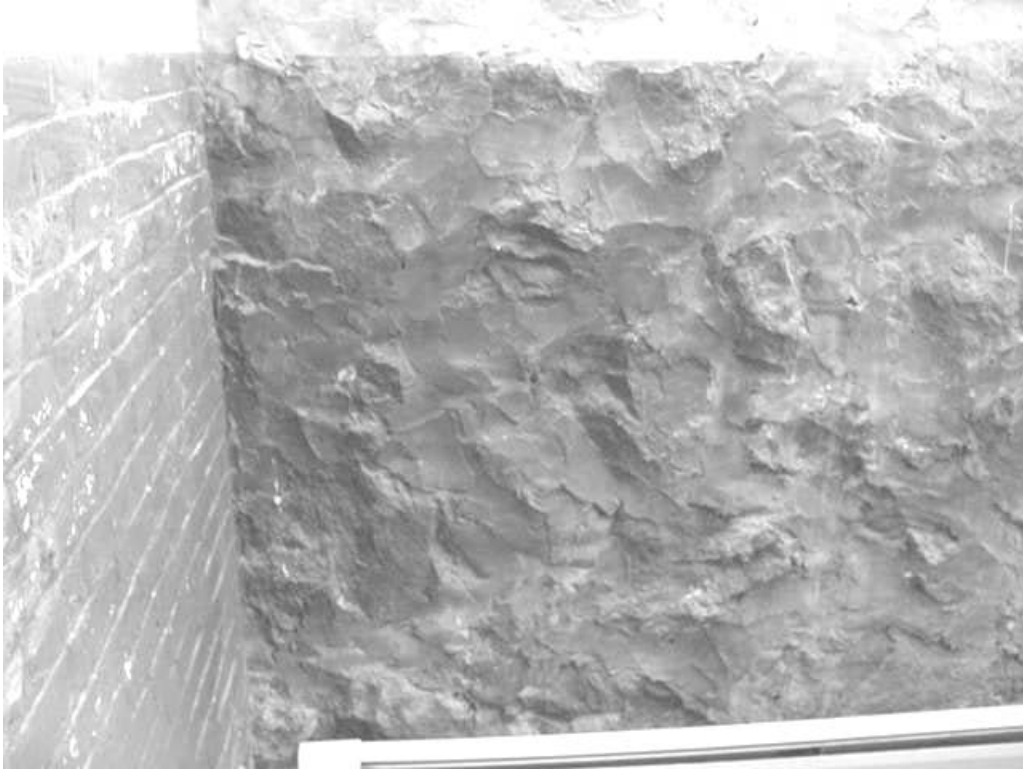
Picture 3

Band Room Wall Stripped Down to Brick/Rock Foundation

Action Taken: At the time of the February 21, 2003 visit, the entire suspended ceiling tile system, wall paneling, wooden framework and wall paneling were removed. The carpet had not been removed at that time. BEHA staff recommended that the carpet should be removed, which was agreed upon by BSD officials. All non-porous materials were reportedly disinfected with a one in ten bleach solution and cleaned thoroughly with soap and water. BSD maintenance staff also installed a local exhaust fan in this room to create conditions of depressurization, which should prevent/limit, any potential odor migration. This room will reportedly be sealed and not be used for the remainder of the 2002-2003 school year.

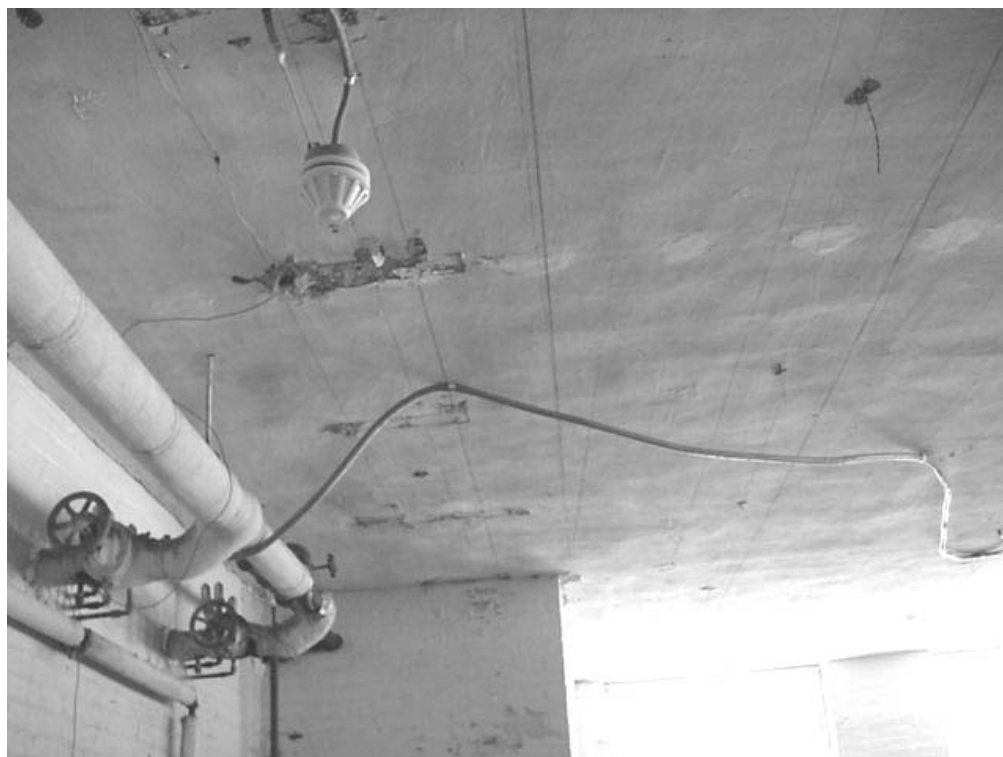
Picture 4

Ceiling of Band Room with Suspended Ceiling Tile System Removed

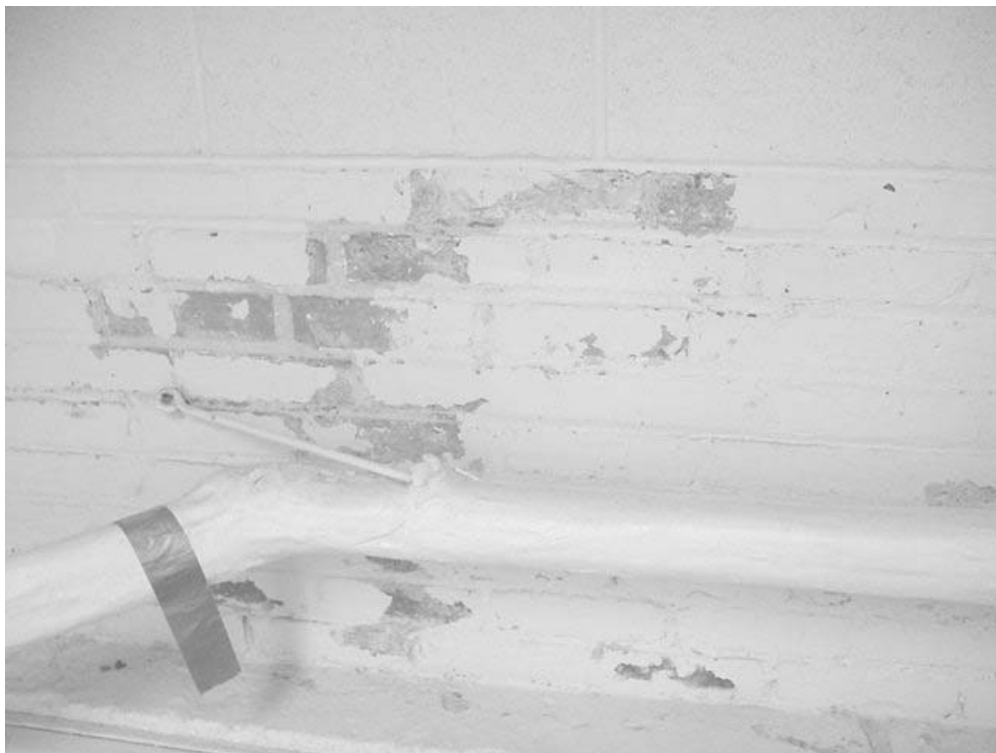
Picture 5

Basement Classroom Wall Where Loose Paint was Removed and Sanded Down

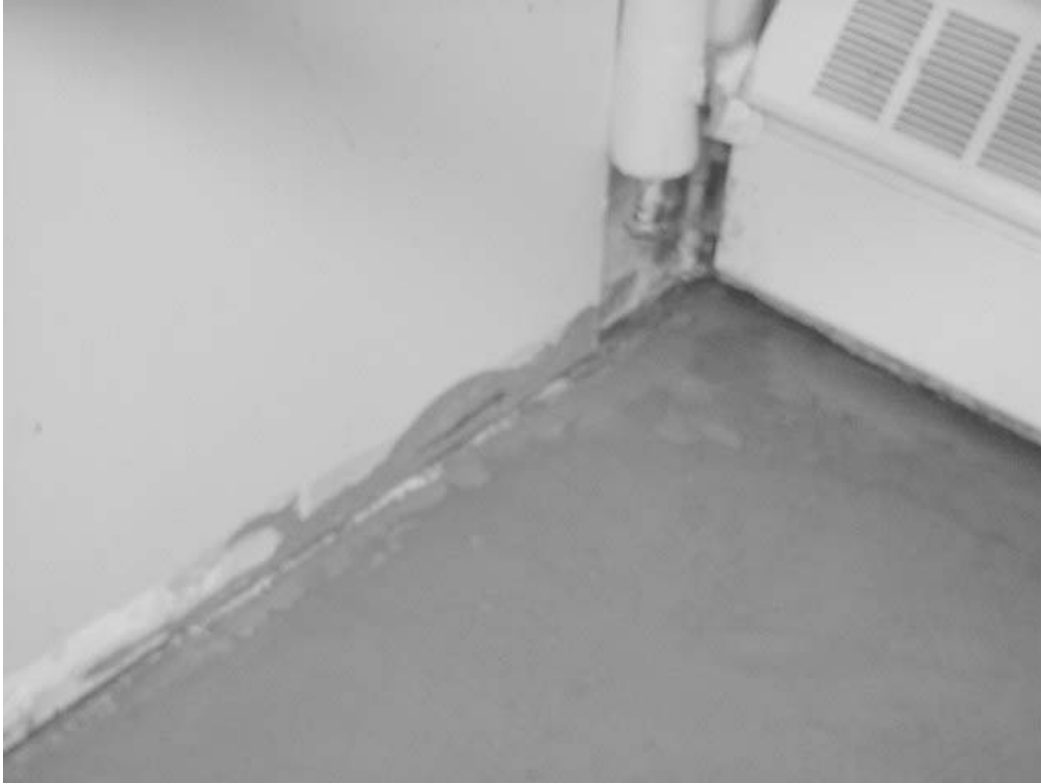
Picture 6

supporting mold growth. Measurements were taken in areas with the greatest potential for water damage, primarily along the base of GW in basement classrooms 2-O and 2-M where rubber coving was removed (see Picture 6). The moisture meter probe was inserted into the surface of GW on walls at intervals of approximately every three feet, three to six inches above the floor. The Delmhorst probe is equipped with three lights as visual aids to determine moisture level. Readings, which activate the green light, indicate a sufficiently dry level (0 - 0.5%), those that activate the yellow light indicate borderline conditions (0.5 – 1.0%) and those that activate the red light indicate elevated moisture content (> 1%). All results were in the dry range (0 - 0.5%). In addition, visual inspection of classrooms 2-O and 2-M suggested no obvious water damage or visible microbial growth on GW.

Base of GW Where Rubber Coving was Removed

Action Taken: Rubber baseboard coving was removed (see Action 3). BEHA staff visually inspected GW that was beneath rubber coving for mold growth/water damage and conducted moisture readings in the GW. No visible mold growth was observed nor measurable moisture reading obtained.

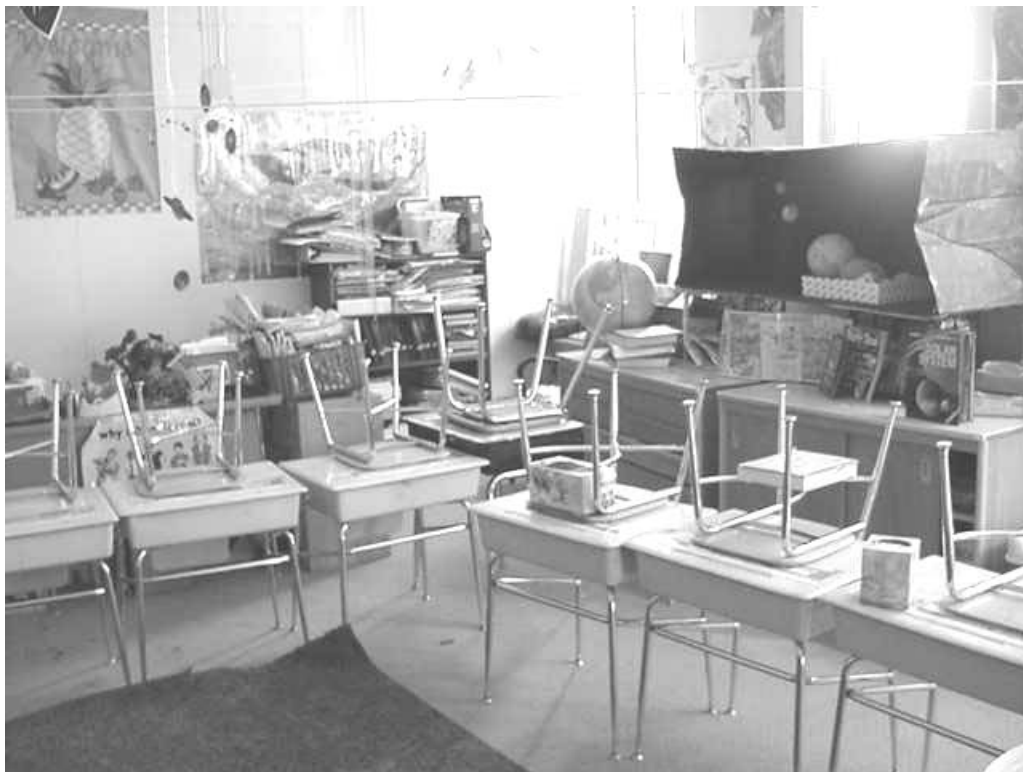
Picture 7

Several other conditions were noted during the assessment, which can affect indoor air quality. For the most part, these conditions can be improved by the active participation of building occupants. As mentioned in the previous report in classrooms throughout the school, items were observed on windowsills, tabletops, counters, bookcases and desks (see Picture 7). The large number of items stored can provide a source for dusts to accumulate. These items (e.g., papers, folders, boxes, etc.) also make it difficult for custodial staff to clean. Dust can be irritating to eyes, nose and respiratory tract. Items should be relocated and/or be cleaned periodically to avoid excessive dust build up.

Accumulated Items on Flat Surfaces in Classroom

4. Relocate or consider reducing the amount of materials stored in classrooms to allow for more thorough cleaning. Clean items regularly with a wet cloth or sponge to prevent excessive dust build-up.

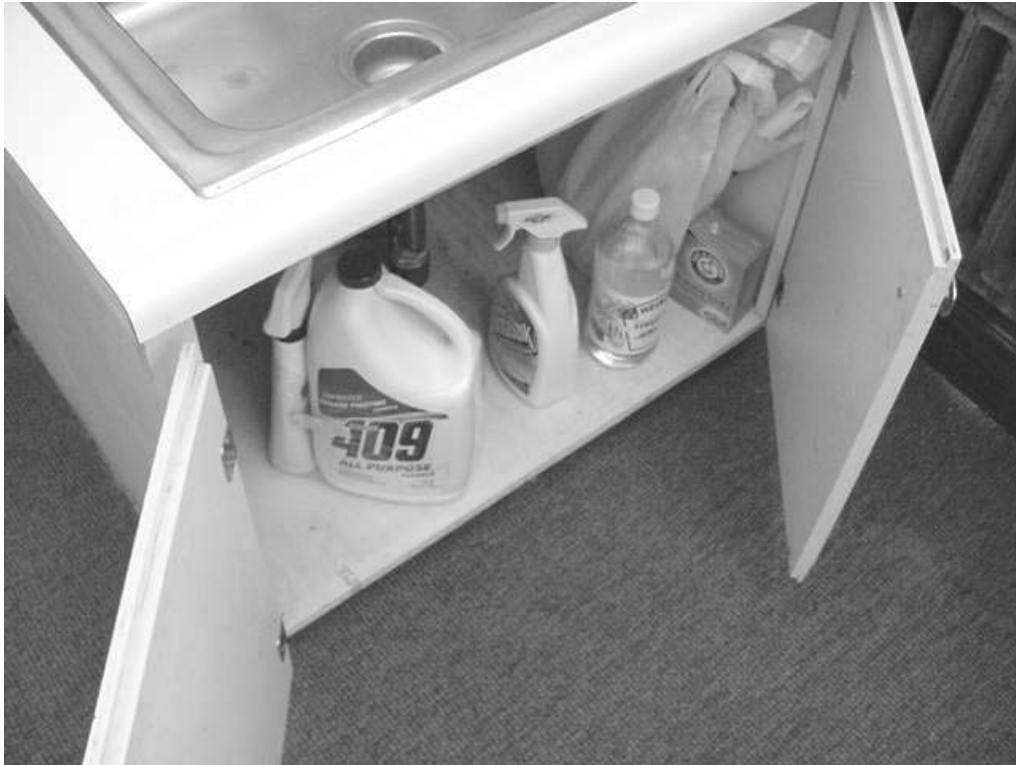
Picture 8

Also mentioned in the previous report were cleaning products and other chemicals found in floor level cabinets and on counter tops in several classrooms (see Picture 8). Cleaning products contain chemicals (such as bleach or ammonia-related compounds), which can be

irritating to the eyes, nose and throat. In some cases products found were labeled flammable or contained acetone, an extremely irritating organic solvent. These items should be stored properly and out of the reach of students.

Spray Cleaning Chemicals beneath Unlocked Sink in Classroom

5. Store cleaning products properly and out of reach of students. Refrain from using strong scented (e.g. air fresheners) and/or VOC-containing materials. Consider removing flammable materials from the building.

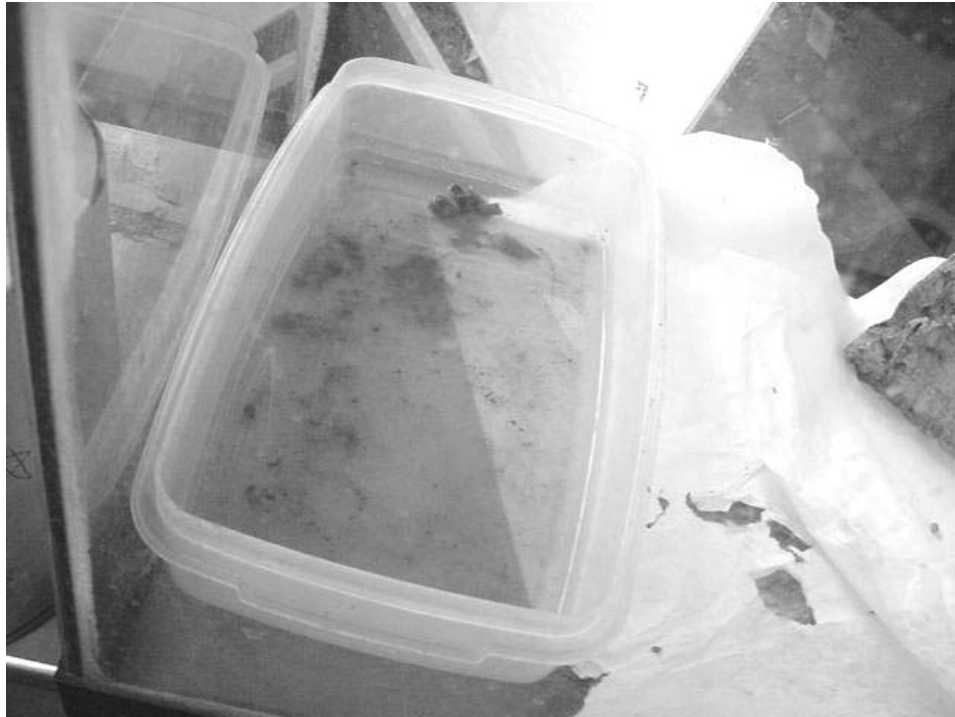
Picture 9

A container housing a box turtle was seen in classroom 12 on February 21, 2003 (the Friday ending the February vacation week). The container holding the turtle contained standing water, waste materials matter and a green material that may be mold or algae growth (see Picture 9).

**Turtle Container with Standing Water, Waster Material and Mold/Algae Growth
(As indicated by dark stains)**

8. Consider discontinuing the use of tennis balls on chairs to prevent latex dust generation.
9. Clean turtle container regularly, change water and disinfect as needed.

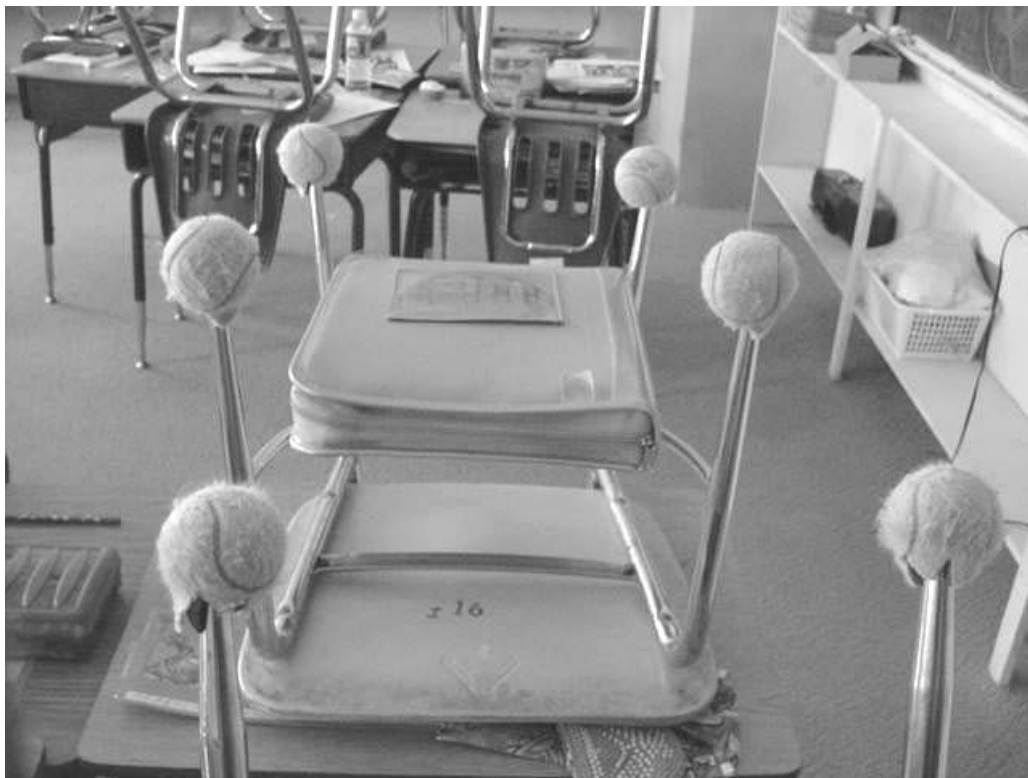
Picture 10

Finally, in an effort to reduce noise from sliding chairs, tennis balls had been sliced open and placed on chair legs (see Picture 10). Tennis balls are made of a number of materials that can be a source of respiratory irritants. Constant wearing of tennis balls can produce fibers and off-gassing volatile organic compounds (VOCs). Tennis balls are made with a natural rubber latex bladder, which becomes abraded when used as a chair leg pad. Use of tennis balls in this manner may introduce latex dust into the school environment. Some individuals are highly allergic to latex (e.g., spina bifida patients) (SBAA, 2001). It is recommended that the use of materials containing latex be limited in buildings to reduce the likelihood of symptoms in sensitive individuals (NIOSH, 1997). A question and answer sheet concerning latex allergy is attached as [Appendix II](#) (NIOSH, 1998).

Tennis Balls on Bottom of Chair Legs in Classroom

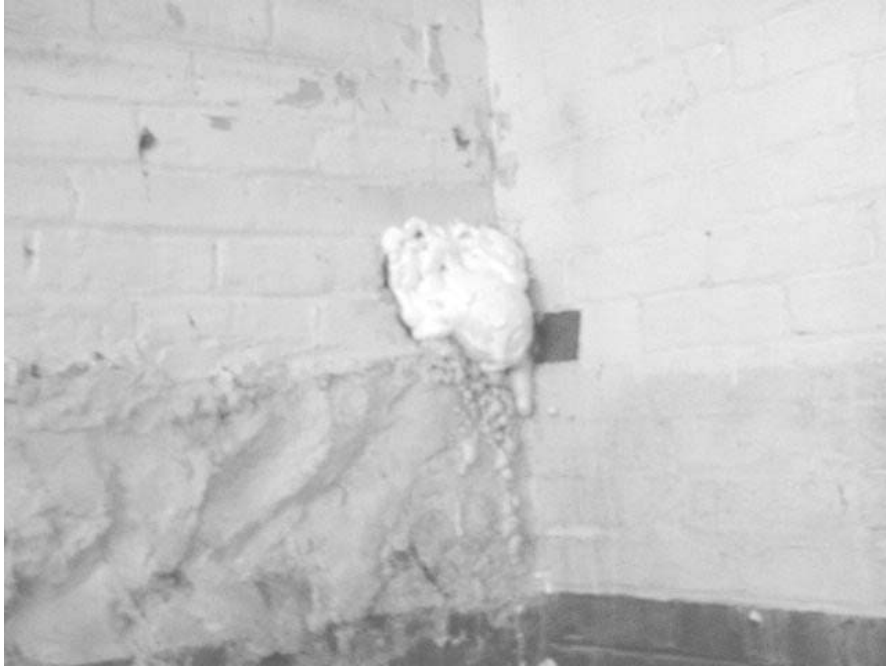
Picture A-1

Action Taken: Ceiling tiles were removed and utility holes throughout the building were sealed with an expanding foam insulation material (see Pictures A-1 & A-2).

Foam Insulation Used to Seal Utility Holes in Band Room

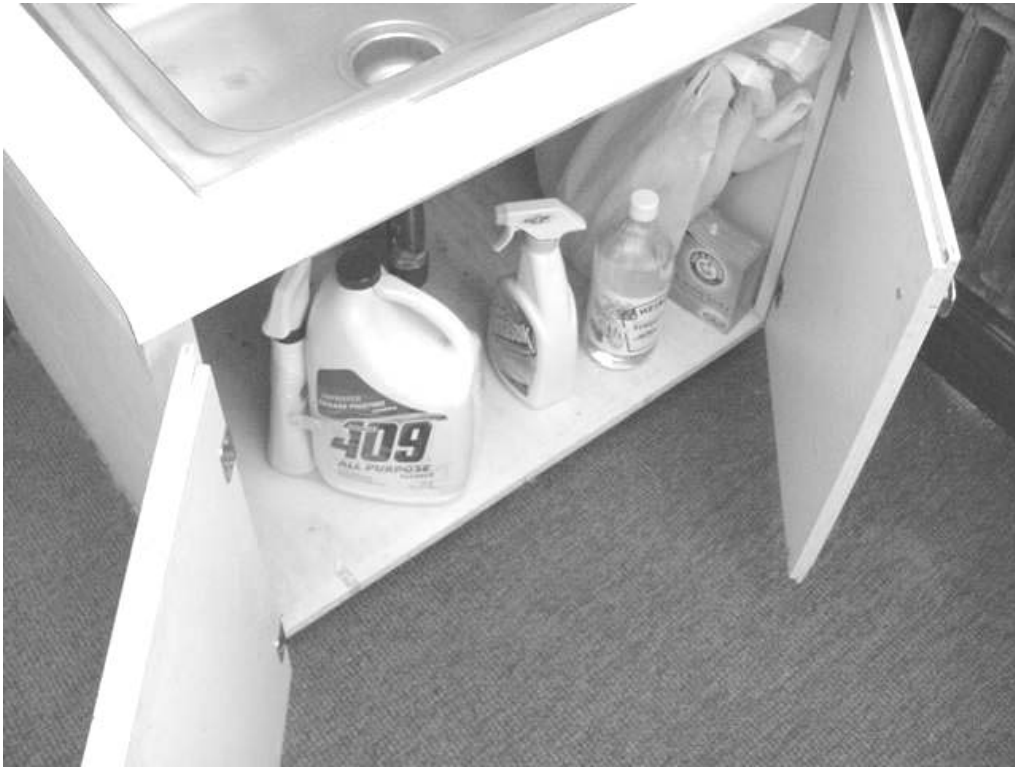
Picture A-3

Action Taken: School staff were informed to remove personal cleaning products from the school, however, BEHA staff observed a number of cleaning products and other household

chemicals (including flammable materials) on classrooms shelves and in floor level storage cabinets (see Pictures A-3 & A-4).

Spray Cleaning Products Beneath Unlocked Sink in Classroom

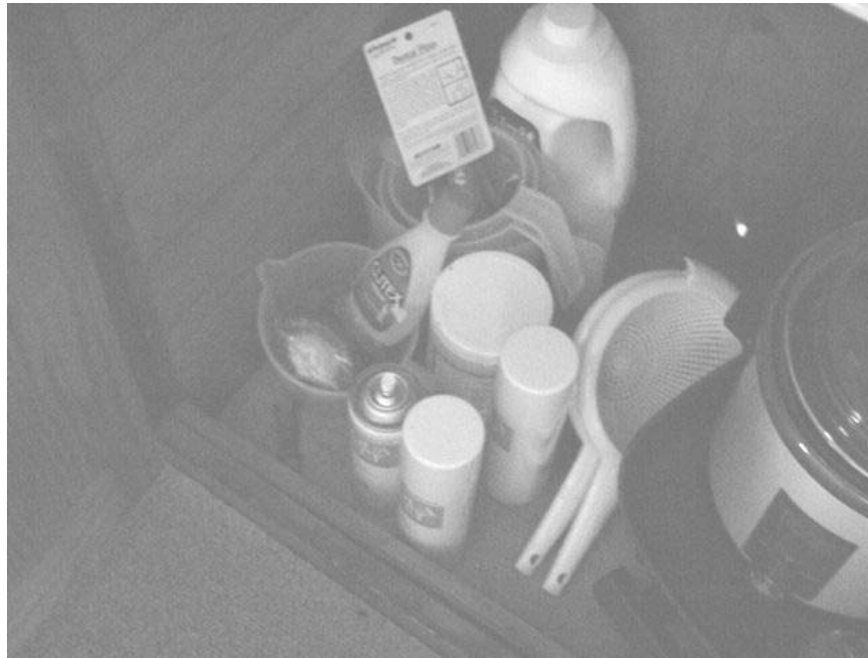
Picture A-4

Materials in Unlocked Classroom Floor Cabinet, Including Cans of Hairspray and Nail Polish Remover Labeled Extremely Flammable
